## Minerals Inspection Report

Mine Name: Moss Rock	Permit Number: S/49/0059	Mine Status: Inactive
Operator Name: Vern Tharp	Inspection Date: 07/28/2014	Permit Fees: 0*
Inspector(s): A. Abate	Inspection Time: 1:00 PM	Bond Amount: \$3,500
Attendee(s): V. Tharp	Weather: Cloudy 70s	Bond Escalation: due
Inspection Purpose: Bond Release		Prior Inspection: 6/8/2011

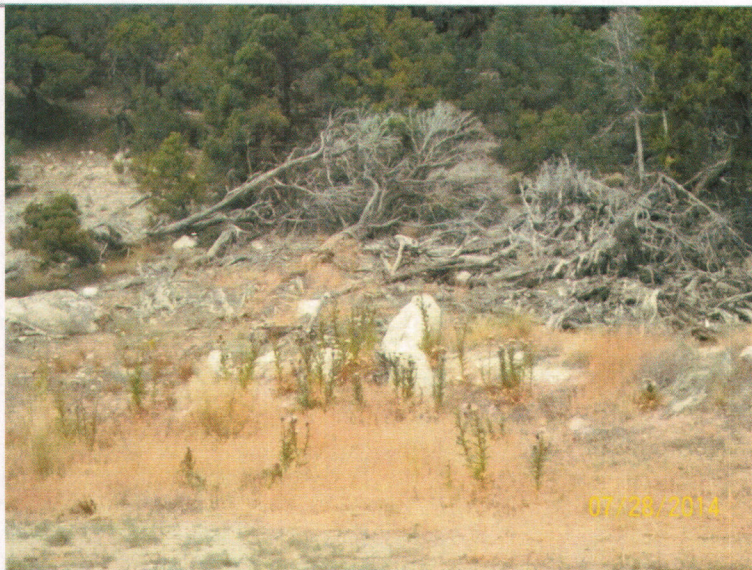
8. <i>Soils</i>	<input type="checkbox"/>	<input type="checkbox"/>
9. <i>Revegetation</i>	<input checked="" type="checkbox"/>	<input type="checkbox"/>
Vegetation on the road inslopes was present but fairly sparse. This area was seeded three years ago and even though the vegetation was thin it did not look unnatural. The stretch of road that was underlain by clay was approx. 200 feet of road. Mr. Tharp is prepared to line this stretch of road with gravel to fix the problem cited in the previous inspection. In addition to these prior issues, areas of musk thistle were noted along the road. Mr. Tharp was informed that the weeds will need to be removed.

Clusters of musk thistle was present alongside stretches of the road.

Operator requested an inspection to determine what reclamation work is needed to achieve a full bond release. I asked Mr. Tharp to lay down the gravel for the stretch of road requiring repair and also directed him to remove the musk thistle from the property. If he completes this work by the end of the field season, I recommend full bond release. Will need to conduct a follow up inspection in 2014. No permit fee is due this year if reclamation is completed in 2014.

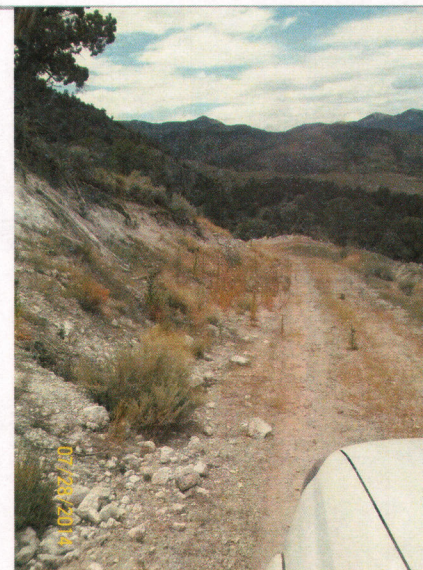
Vegetation on the inslopes of the road was immature but present. It did not appear unnatural or require any additional seeding.

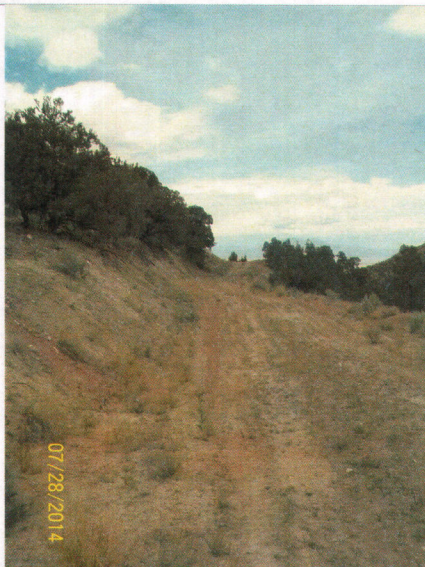
Elements of Inspection	Evaluated & Commented	Enforcement
1. <i>Permits, Revisions, Transfer, Bonds</i>	<input checked="" type="checkbox"/>	<input type="checkbox"/>
The Division sent a Directive on March 5, 2012 requiring the operator reclaim or post an escalation for the surety. The operator has indicated that he would like to close the permit. The last bond release inspection in 2011 denied the release citing that additional vegetation on the road inslopes was barren and needed seeding. A small patch of road was also cited as being too soft and damp due to the clay material that underlies the area. The Division asked that this area be fixed.

Stretch of the road underlain by clay that requires gravel.
